Dysmorphic Pelves Treatment with the CurvaFix® IM System

James Shaw, MD | McGovern Medical School, Houston, Texas

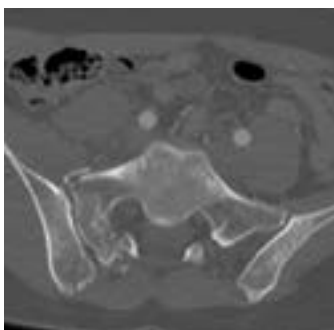
Patient 1: Postoperative

- CurvaFix IM Implants were inserted into the upper sacral segments of both patients.
- Patient 1 received both a straight screw in S2 and a CurvaFix implant in S1. Both wires were placed prior to the implantation of the CurvaFix implant so visibility could be maintained.

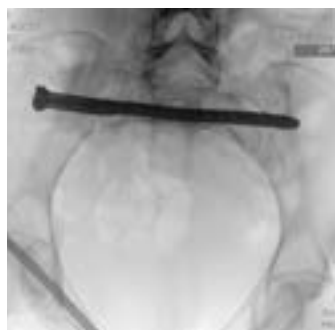
Patient 2: Preoperative CT

Patient 2 sustained a right zone 2 sacral fracture, right parasymphyseal superior ramus fracture and inferior ramus fracture. Patient 2 had more acute sacral dysmorphism than patient 1.

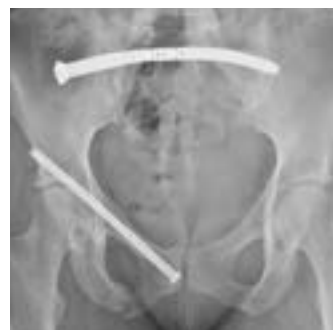
Patient 2: Postoperative

- The steerable guidewire and CurvaFix IM Implant accommodate the curved intraosseous anatomy in patients with pelvic dysmorphism to obtain transiliac-transsacral fixation in the upper sacral segments.
- CurvaFix allowed for transiliac-transsacral fixation that would otherwise not be possible with traditional straight screws.
- Passing wires into both S1 and S2 (patient 1) prior to the CurvaFix IM Implant insertion preserved visibility during the second wire insertion for the straight screw.
